Mold Report

May 1, 2023

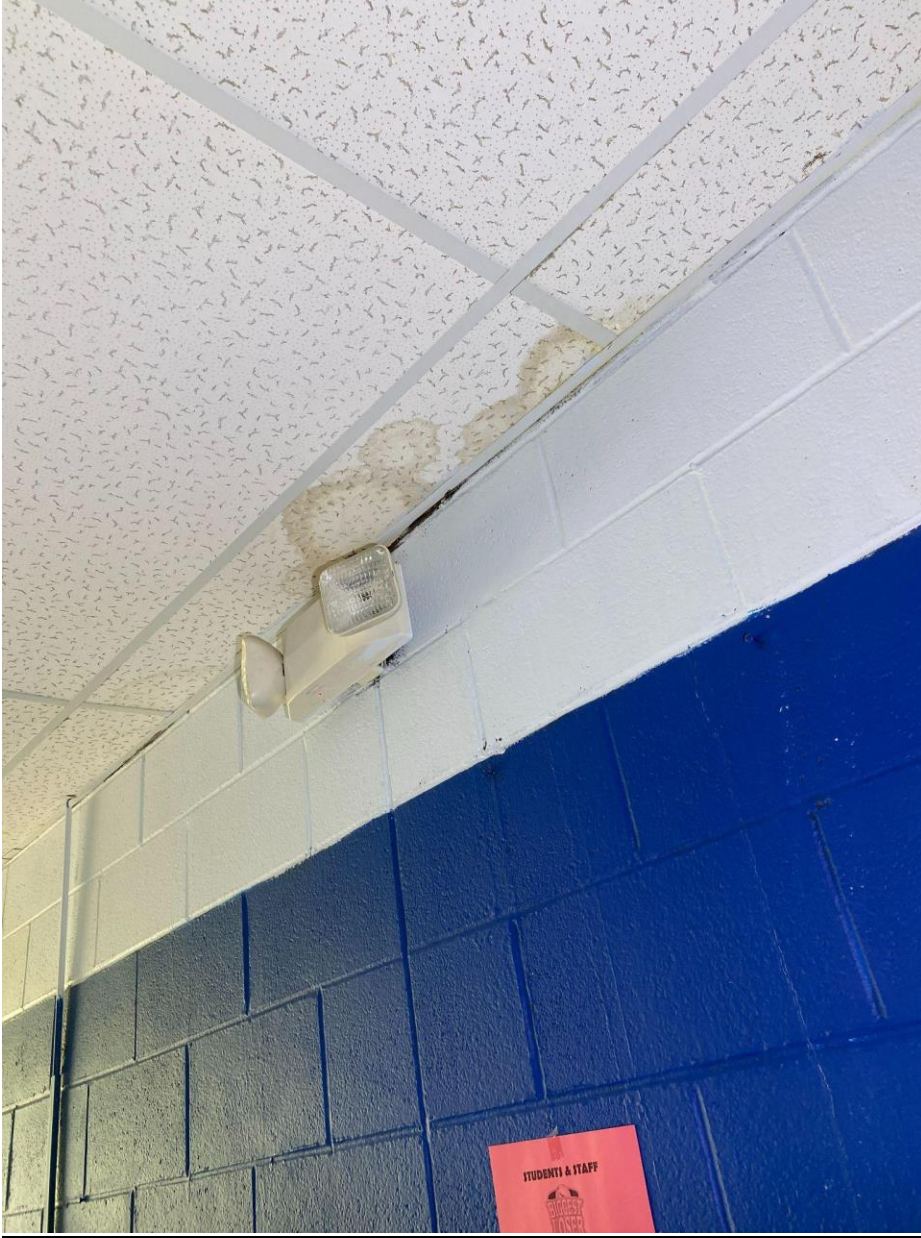
Moisture stains on ceiling tile

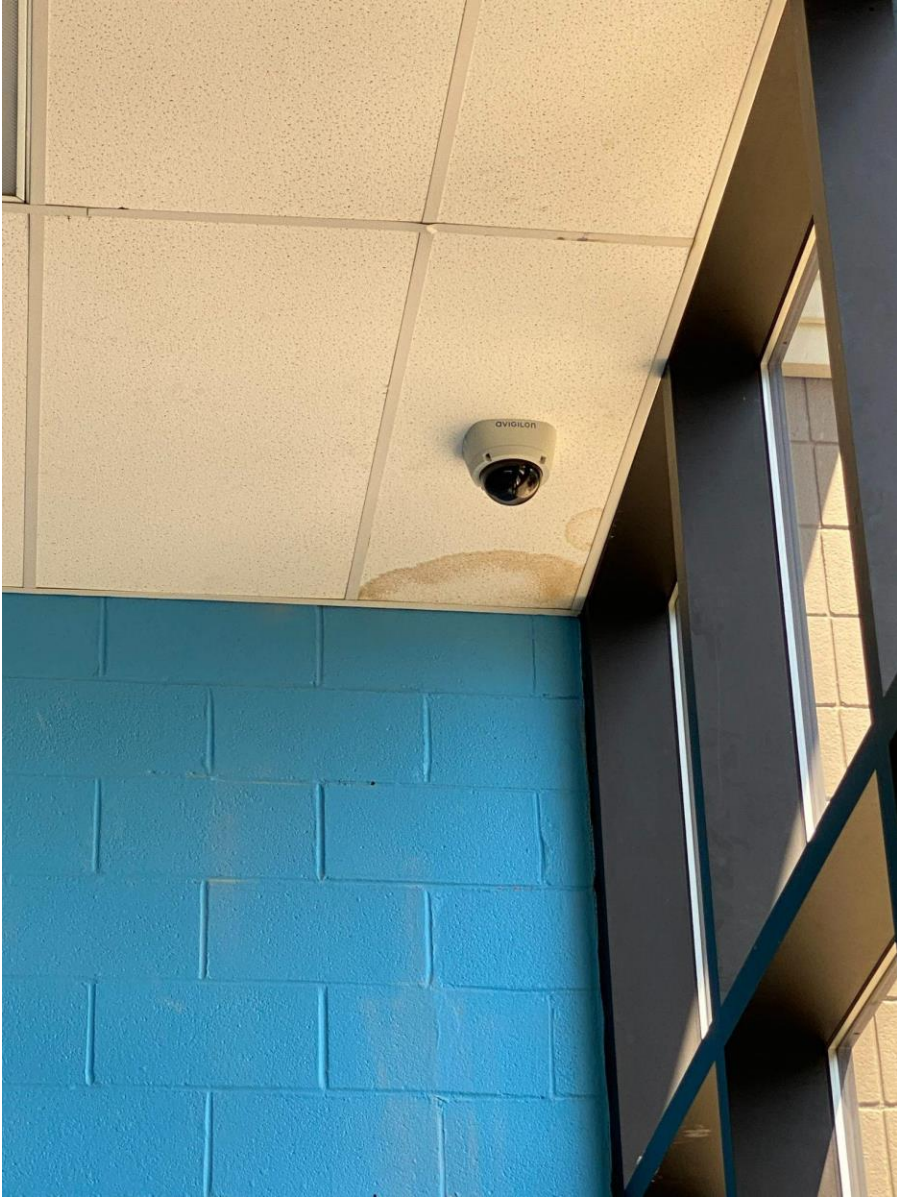
Moisture stains on ceiling tile

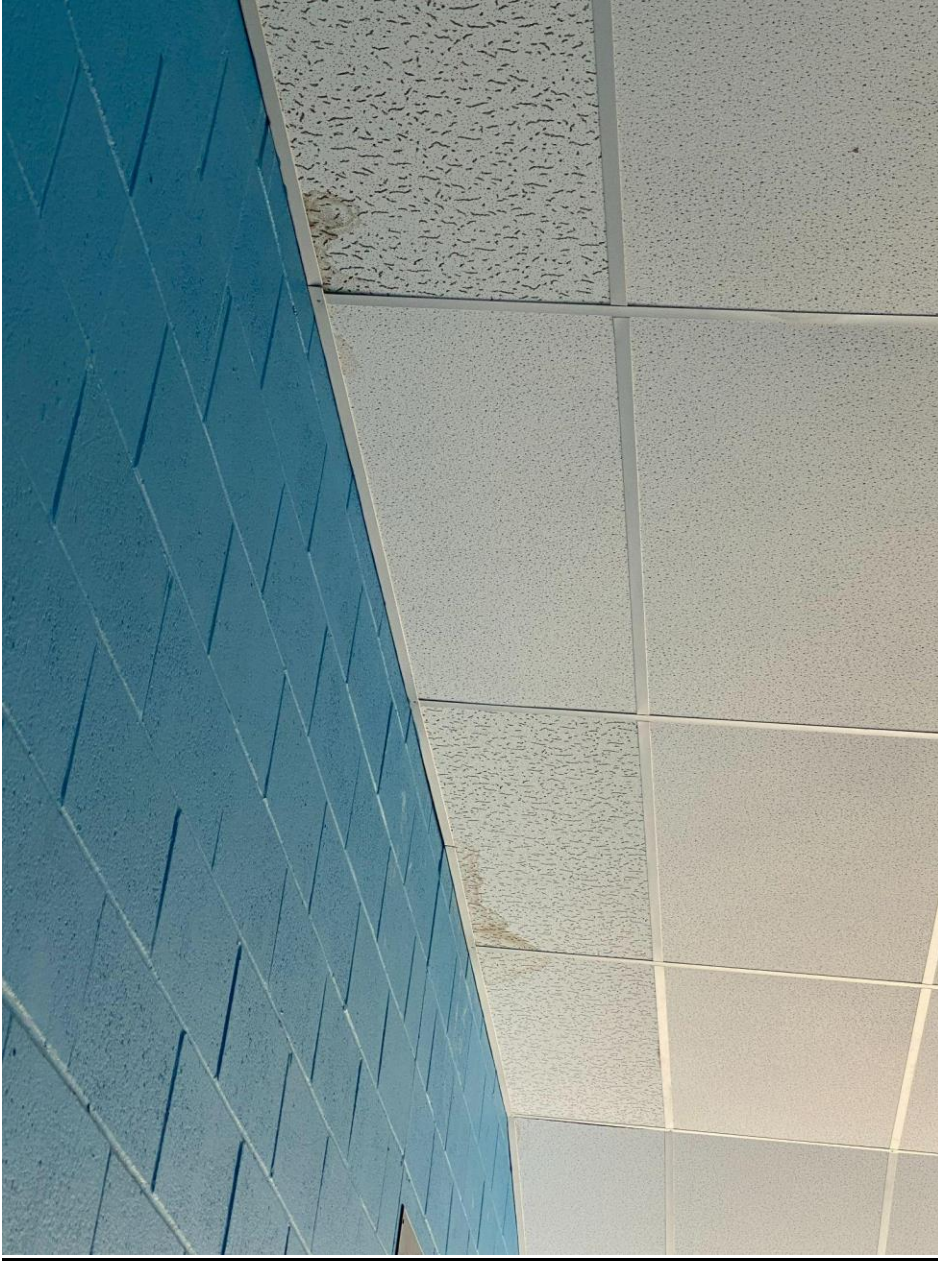
Moisture stains on ceiling tile
